St Mary's church, Ashley

Historical graffiti survey report

August 2023

Hampshire Medieval Graffiti Project

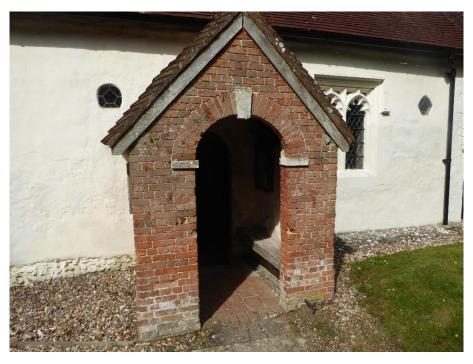
1 The south porch

Over the entrance to the brick porch is a date stone of 1701 with the initials R + L, with CW beneath. The church guide (Vigar, 2005) suggests that these are a pair of churchwardens' initials from that time: RC + LW (Figs 1& 2). Inscriptions with pairs of churchwardens' initials (or their full names), recording works carried out during their tenure are common from the early 18th century. Examples include the 1703 plaque on the rebuilt brick tower at St Andrew's Tichborne, and the wooden table dated 1704 in the new St Peter's church in Stockbridge. In these cases, however, unlike at Ashley, the designation "churchwardens" is included so their status is confirmed.

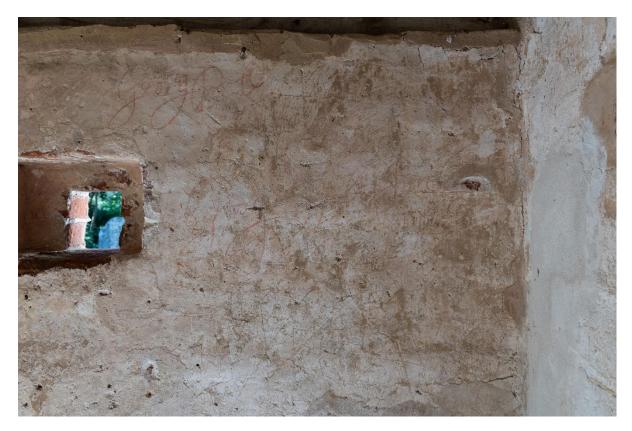
4 Porch interior, west wall

The initials CW, MH, and a single X are inscribed into the bricks on the exterior west wall of the porch.

Inside, on the plastered walls, are various scratched marks and shapes including crossed diagonal lines, and on both east and west walls (Fig 4) is some red-painted writing from the 18th century, seemingly made by the same person, George Poll (Fig 4). Poll is a variation of the name Paul or Pool. The dates 1707/8 and 1712 are associated with repetitions of this name. A process called DStretch was applied to some images. This technique enhances the pigment colours to show up detail. Figs 5, 6 & 7 demonstrate the use of this technique on sections of the west wall where the name George Poll, followed by the date June 1712, can be seen very clearly.

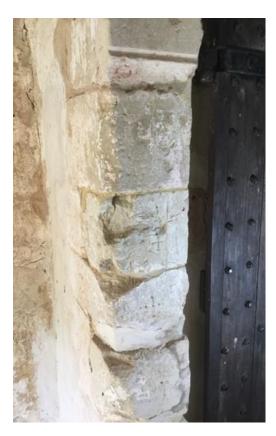
9 South doorway, west jamb

The largest concentrations of graffiti within churches are usually found around the entrances, and Ashley church is no exception. There are many crosses, the main Christian symbol, incised on each side of the doorway and on the jambs (Figs 9 & 10).

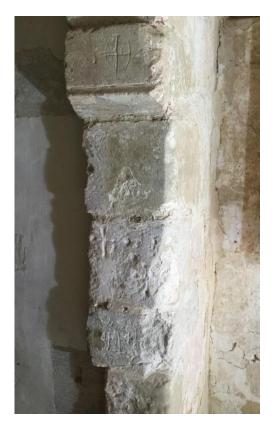
10 South doorway, east jamb

It used to be thought that these were marks left by pilgrims, on their way to the shrines at Winchester and Canterbury. While this may have an element of truth – it is a tradition continued by modern day pilgrims – it is now thought that these marks may also have been left by local parishioners, as symbols of prayer and devotion. These crosses take different forms, some are crudely made, others are more finely incised. Some have dots at the terminals, which may have been made first as guides for cutting the shape. These are known as budded crosses (Fig 11). One cross on the impost on the east side is enclosed within a circle and can be seen in Fig 10.

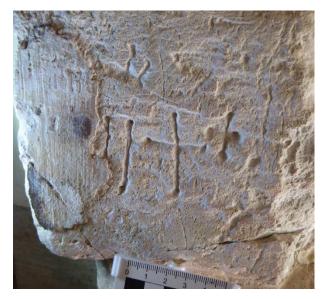
11 South doorway, west jamb, budded crosses

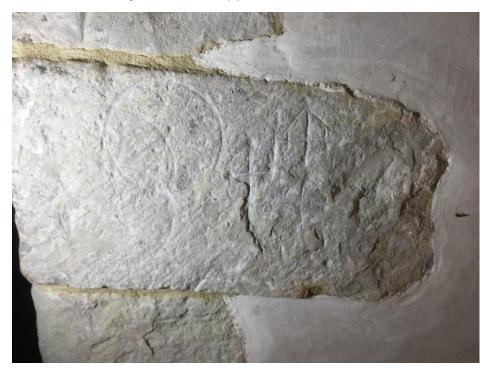
On the east jamb of the doorway one block of stone has 2 crosses whose terminals are joined to form a triangular shape at the top. Next to these are some compass-drawn intersecting circles (Fig 12). These circular motifs are common finds in churches, and also in post-Reformation domestic contexts where they are thought to be apotropaic in function, made to protect the building and its occupants from evil. They are usually found around building openings such as doorways, windows and chimneys. Similar circular symbols also appear on the chancel arch, see later for discussion.

12 South doorway, east jamb. Intersecting circles and crosses

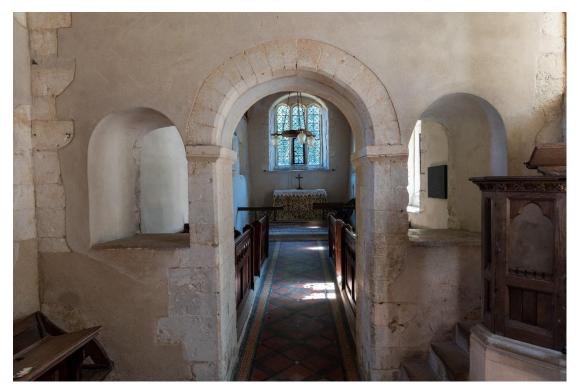
14 The chancel arch, looking east

The chancel arch is Norman in date, with later openings on each side, made to improve parishioners' views into the chancel (Fig 14).

Graffiti was found on both sides of the arch, on the jambs and the surfaces facing into the nave and chancel.

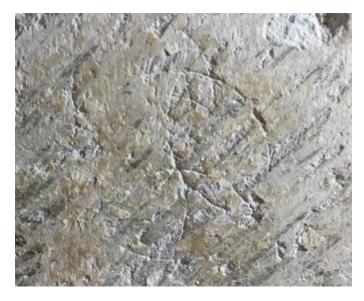
On the north jamb of the arch there is one with a concentric border, which is quite worn, with another circle above it (Fig 16). Just below these are traces of more intersecting examples.

16 Chancel arch, north jamb, six-petalled rosette

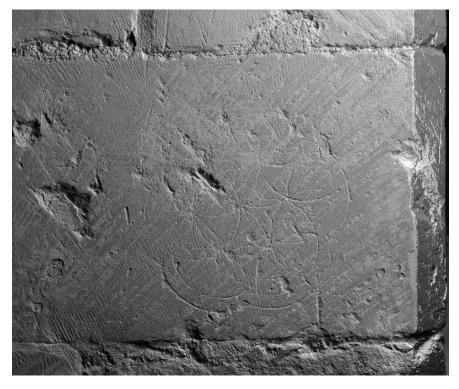
On the south jamb of the arch there are more single examples, and a very finely made and elaborate pattern of intersecting six-petalled rosettes (Fig 17).

17 Chancel arch, south jamb. Interlaced six-petalled rosettes

Although used as ritual protection marks in domestic contexts from the 17th century onwards, these motifs were originally a Christian symbol, found widely in 12th and 13th century contexts, for example on fonts, and only later were supplanted by the cross as the most common Christian icon. The large number of these motifs in this area is unusual and suggests they were made with the acceptance of the church authorities and may have had some particular significance.

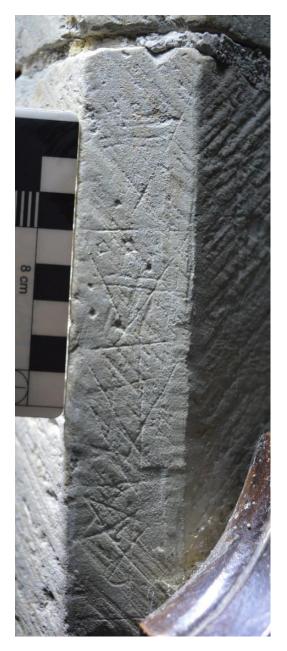
On the north side of the arch, on the chamfered edge, are 3 triangular shapes which probably represent heraldic shields (Fig 19). Each has different patterning inside and they might represent the arms of local families. However, without any colour, it is hard to identify them. Below these shapes is a five-pointed star or pentagram. This is another Christian symbol which evolved into a protective symbol, and later in the post-Reformation period became associated with witchcraft and magic. In Christian iconography it symbolised the five wounds of Christ, and in the legend of Sir Gawain and the Green Knight, it appears on the shield of Sir Gawain, representing his purity and serving as a defence against demons (Champion, 2015).

$19\,$ Chancel arch, north side. Heraldic shields and pentagram

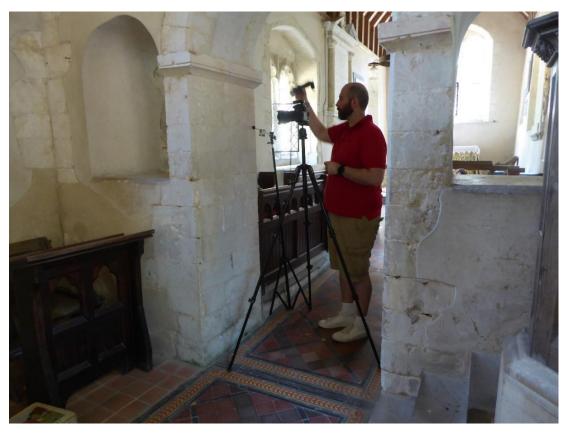
Karen recognised this as a very significant date in relation to the Protestant reforms of the time, when the authorities were trying to stamp out the old Catholic practices which many churches were reluctant to abandon. An inscription at this time suggested it could be a record of a momentous event within this community. At that stage we realised that ordinary photography could not reveal any more of the inscription, so, following a Church Planning meeting led by CCT's Local Community Officer and generous contributions made by the Friends of St Mary's Church and the Hampshire Field Club Historic Buildings Section, the HMGP commissioned a specialist firm, Archaeovision, to photograph the inscription using a technique called Reflectance Transformation Imaging (RTI). The technique involves the taking a series of individual images from a fixed position, each lit (with a flash or continuous light source) from varying directions following the shape of a physical or imaginary umbrella/dome (Fig 23). This survey took place in August 2022.

23 James Miles from Archaeovision carrying out the RTI survey

The resultant sharply-defined images allowed us to view the inscription as a whole and to confirm that it was restricted to one particular block of stone. We sent images to Tom Olding, a medieval Latin specialist and palaeographer, who confirmed the date we had seen and made out the abbreviated words for *huius ecclesiae* - of this church. This, and the use of Latin, added weight to the idea that it had been inscribed by a person who was literate and that it related specifically to this church building.

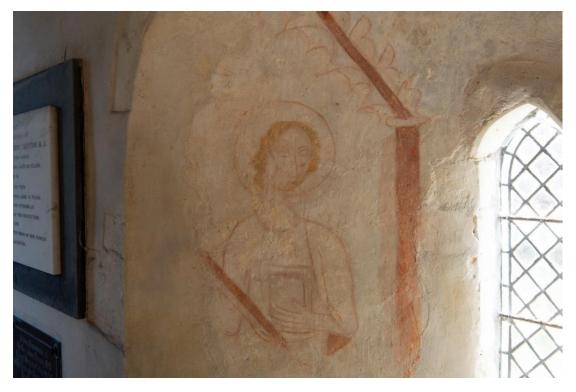
24 Chancel, south window. Restored 13th century wall painting

How tempting it is then, to suppose that this inscription is a unique and exciting find of national significance, inscribed perhaps by Edward Williamson, the rector of Ashley in 1550 or his church warden. Alternatively, it could have been made by a local commissioner acting on behalf of the government, to record that the requirements of the 1550 Act had been carried out, just in the nick of time, and that the church was free from all graven images and idolatrous wall paintings. That these paintings existed is evidenced by the restored 13th century wall painting of a female figure next to the south window in the chancel (Fig 24) and the fainter vestiges of paint that survive elsewhere in the church.
